# V8 ROV CLEANING EXAMPLES

## 'Chain (Australia)

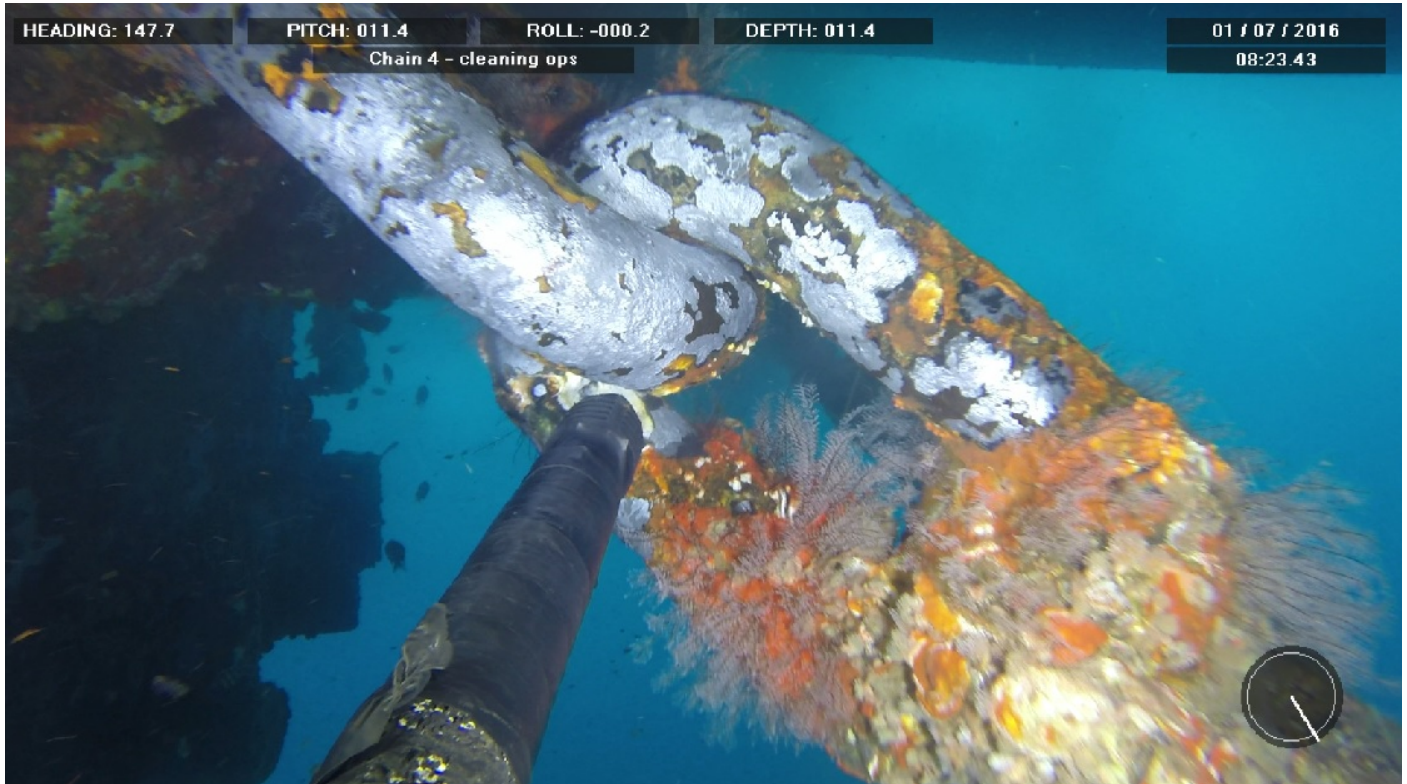
*Cleaning Chain prior to 3d Scanning*

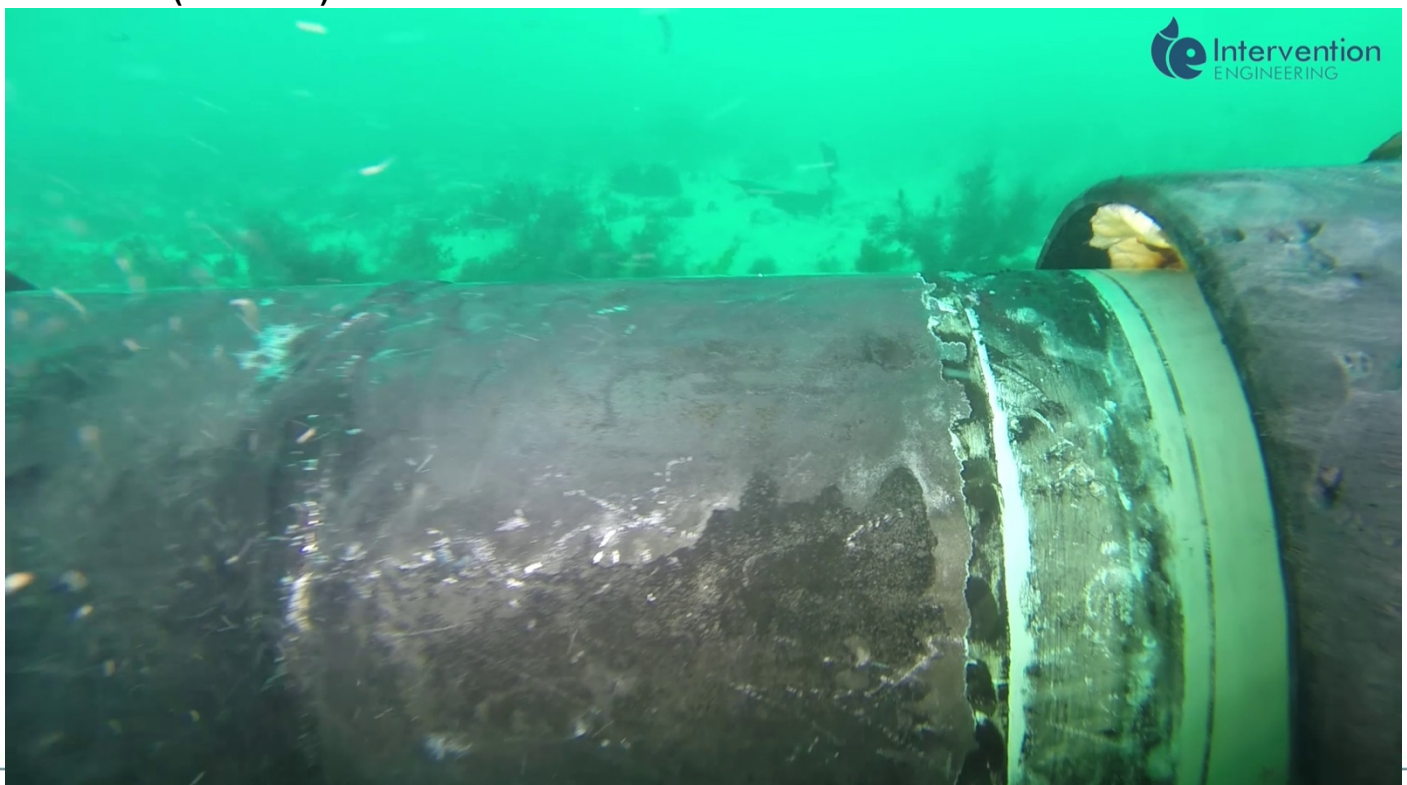
## Field Joint (Australia)

*For this application we removed exterior wraps to expose the joint for UT scanning*

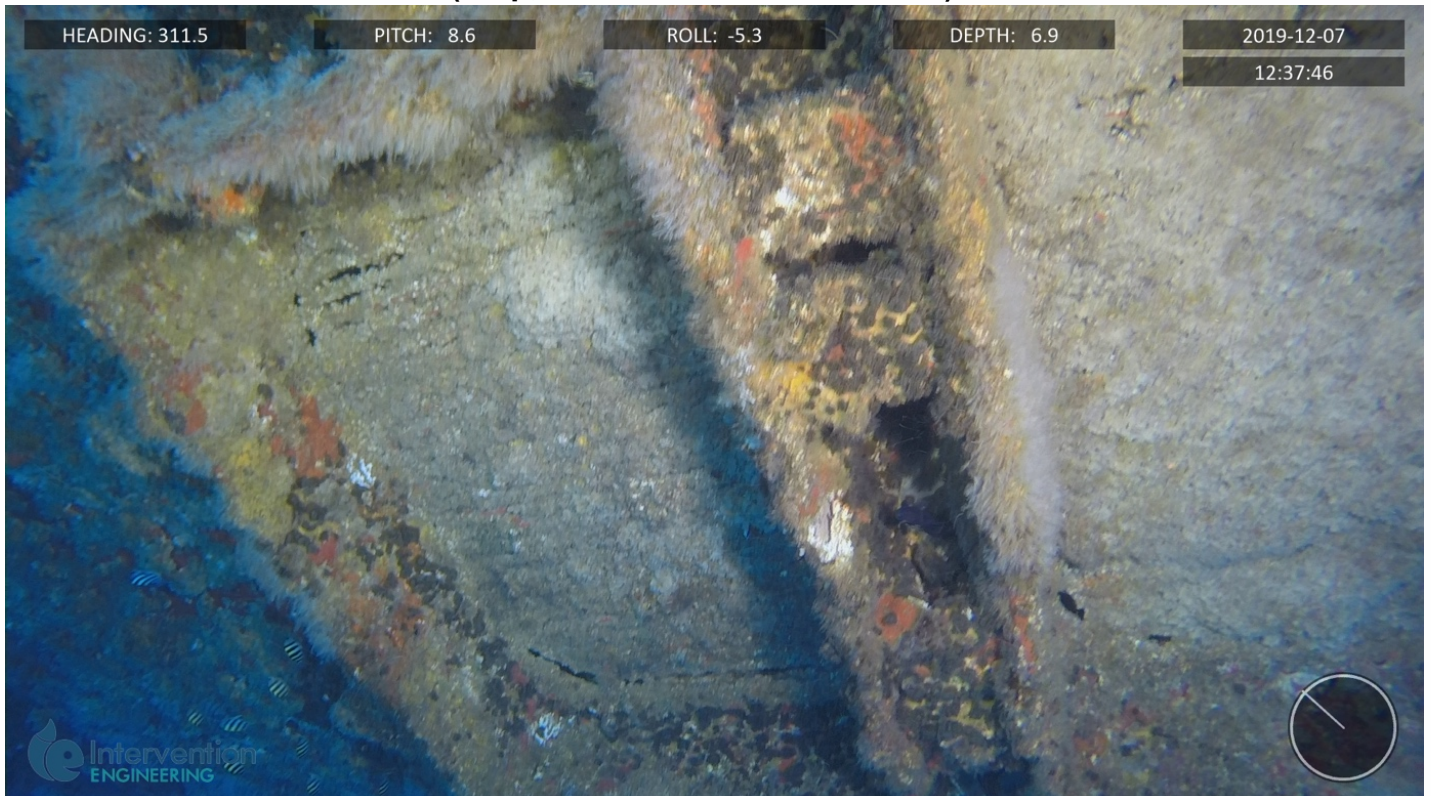
## HP Water on seawater intake (Ship; NorthWest Shelf/Australia)

*Before cleaning and fitting of water blaster showing almost total coverage of soft growth*

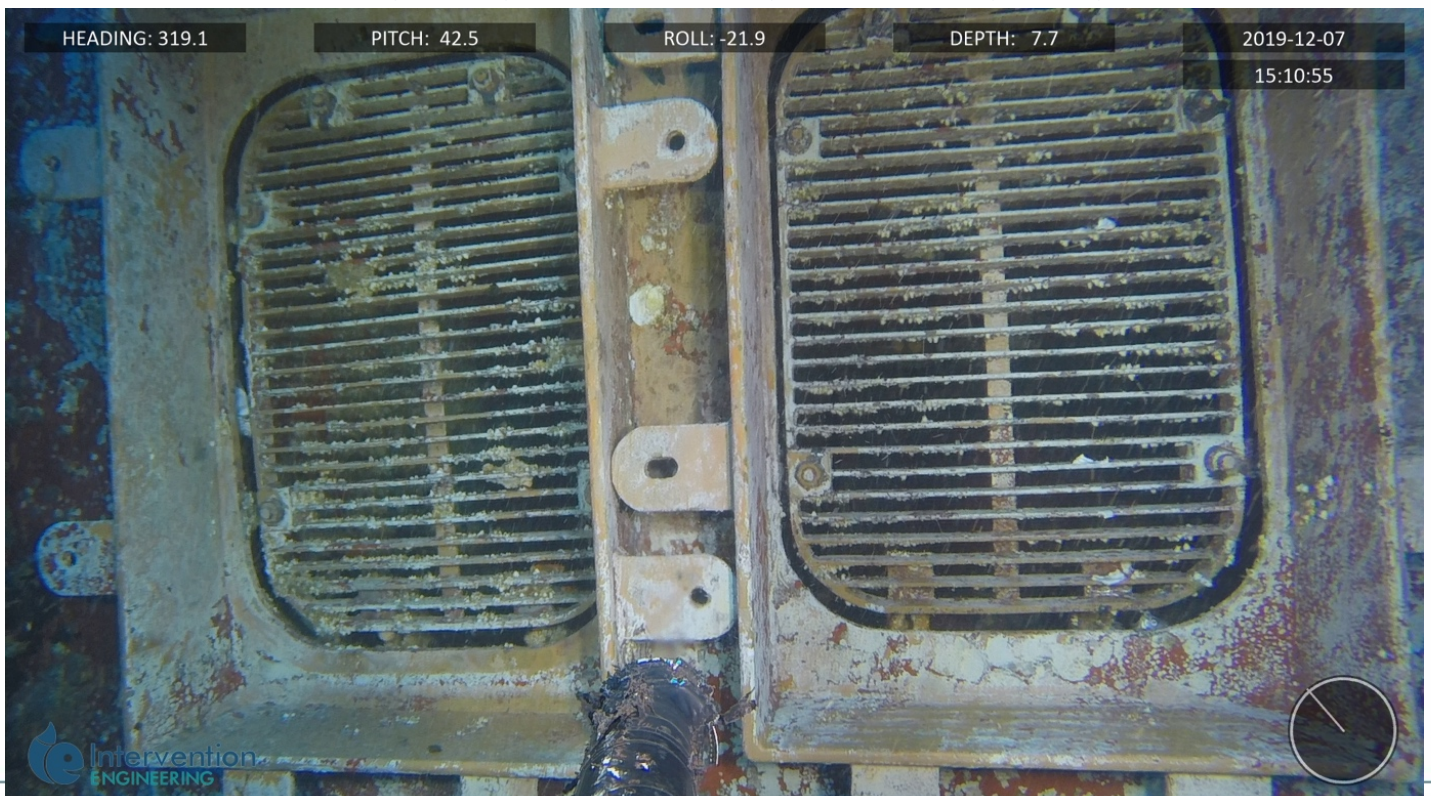
*After about one hour cleaning – Some small amount of hard growth (limpets) and some antifouling coating loss (from cleaning)*

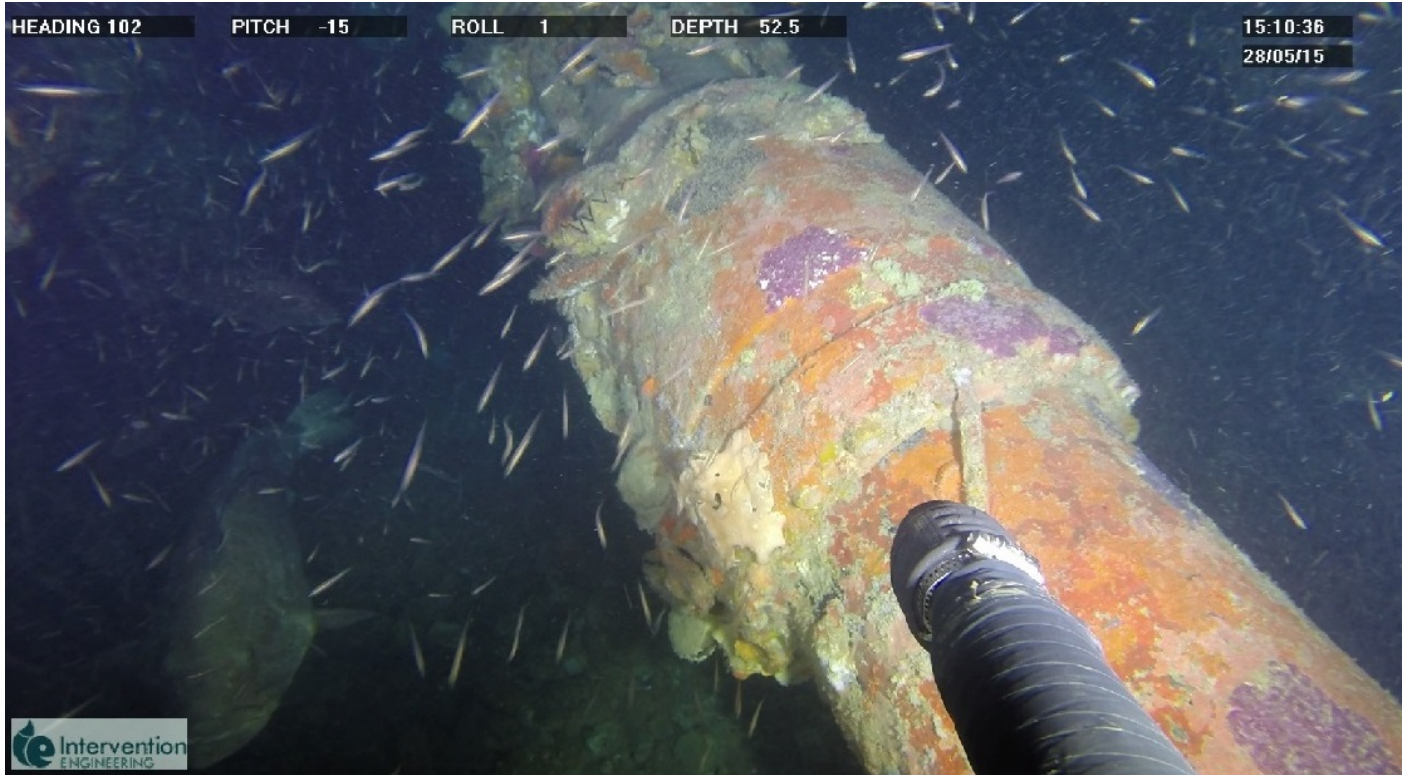
## HP Water on Flange to expose vents(NorthWest Shelf/Australia)

*Before cleaning showing almost total coverage of soft growth*

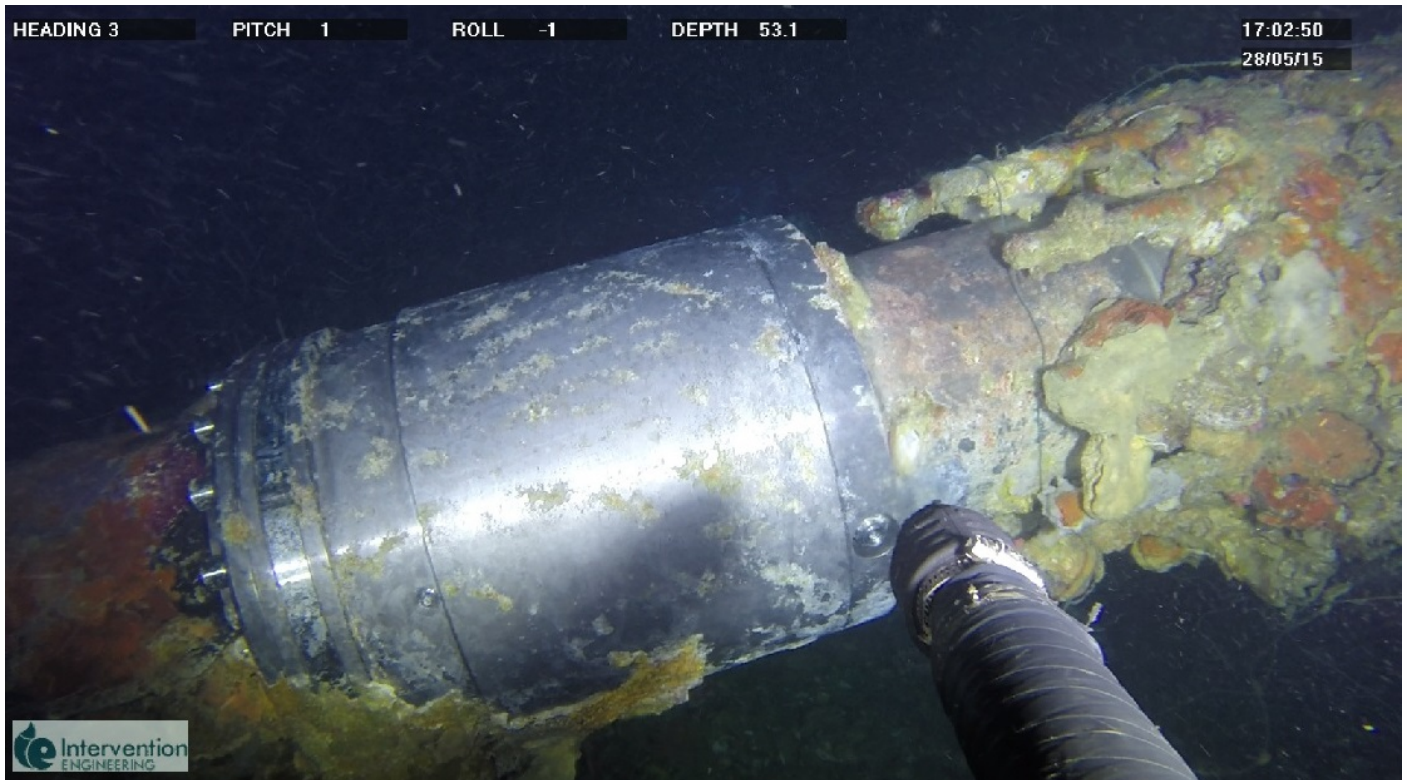
*After partial cleaning – vents are now exposed*

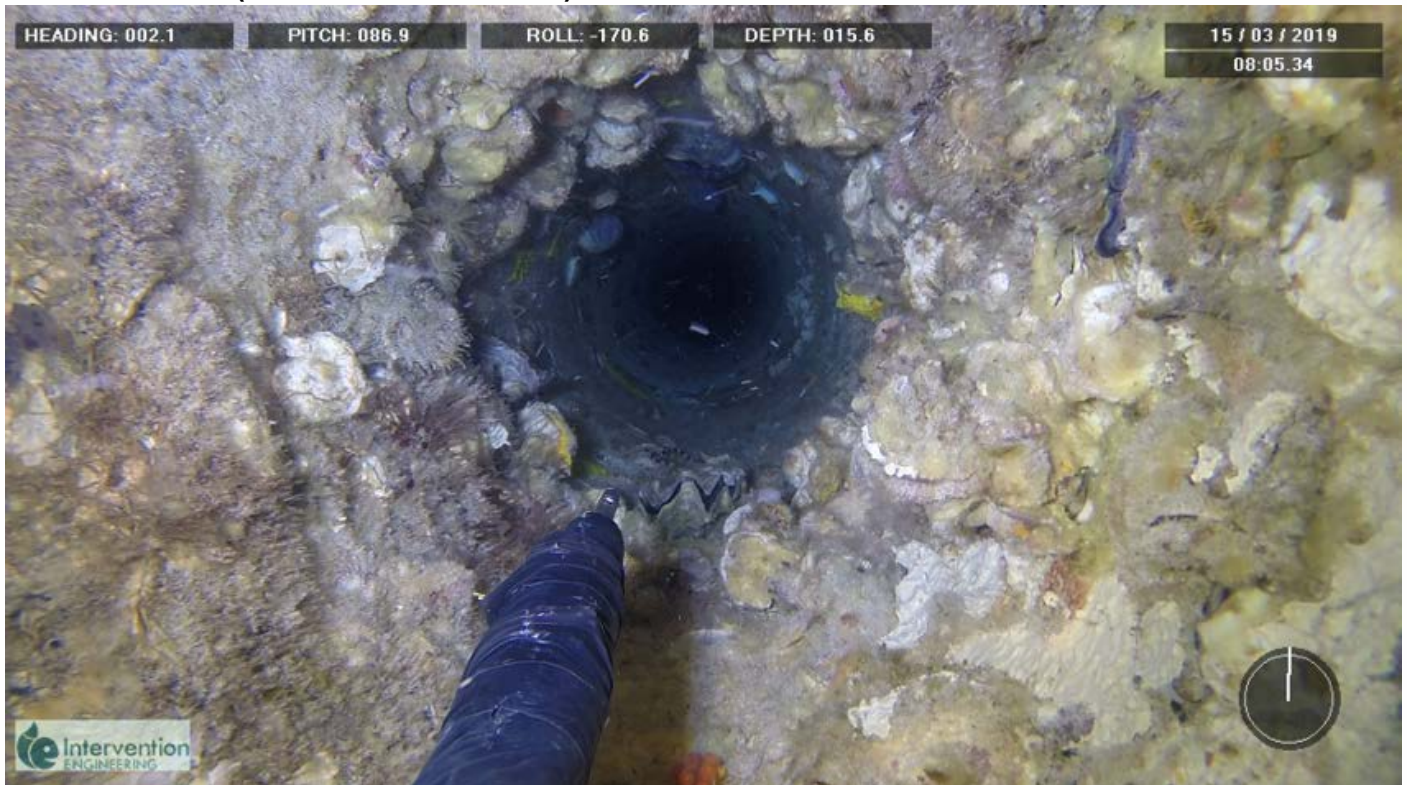
## Unused I-Tube (Timor Sea / Australia)

*Prior to Cleaning (13m long tube)*

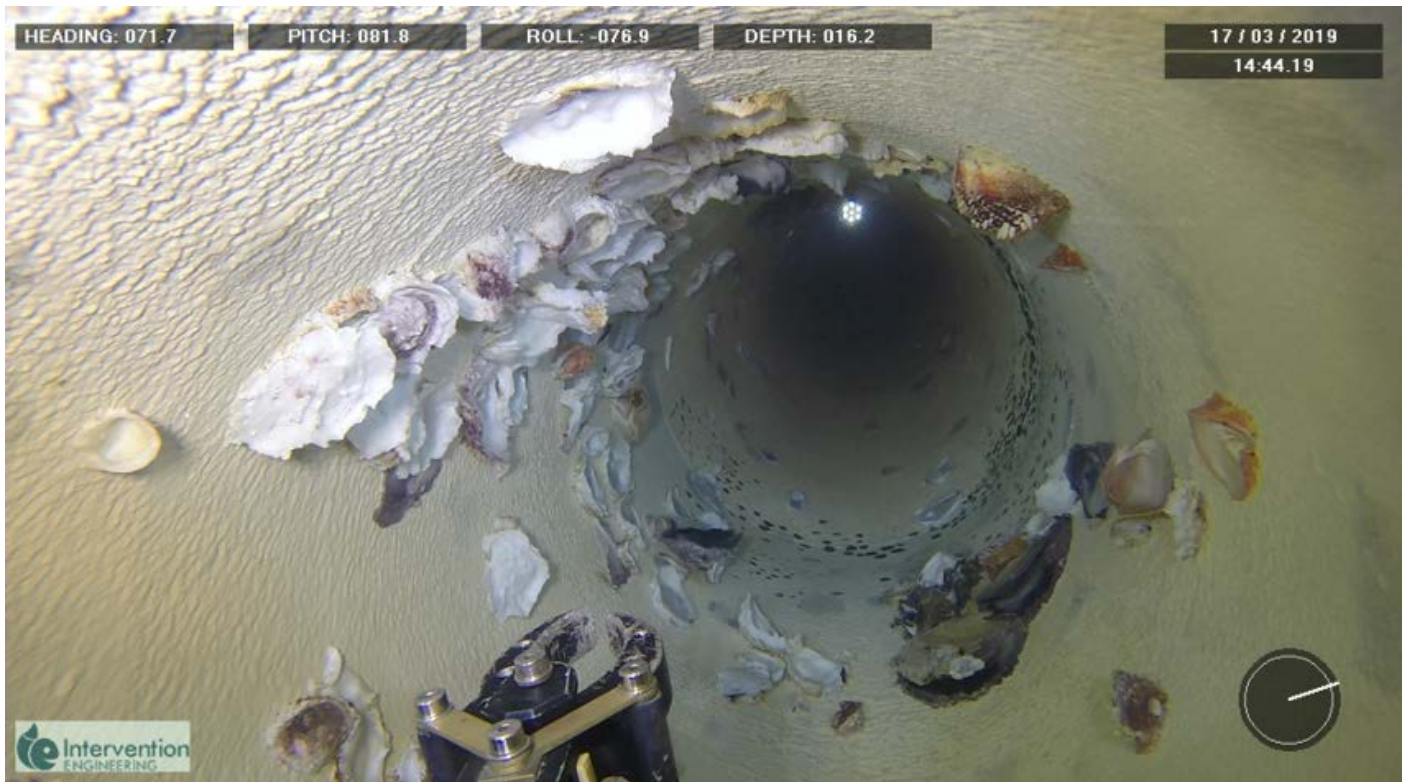
*After Cleaning*

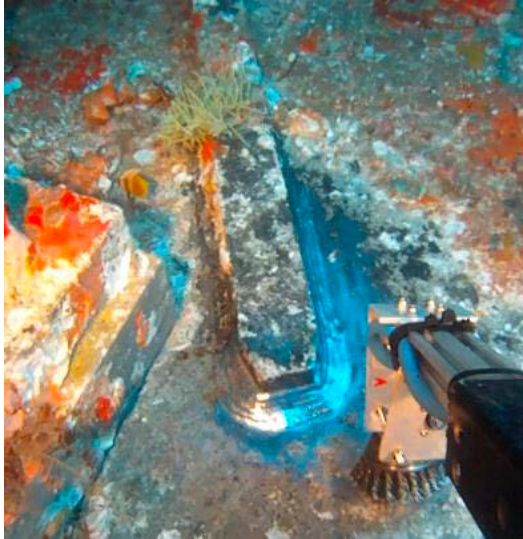
## Wire Brush on Gusset Weld (Platform; Philippines)

During Cleaning

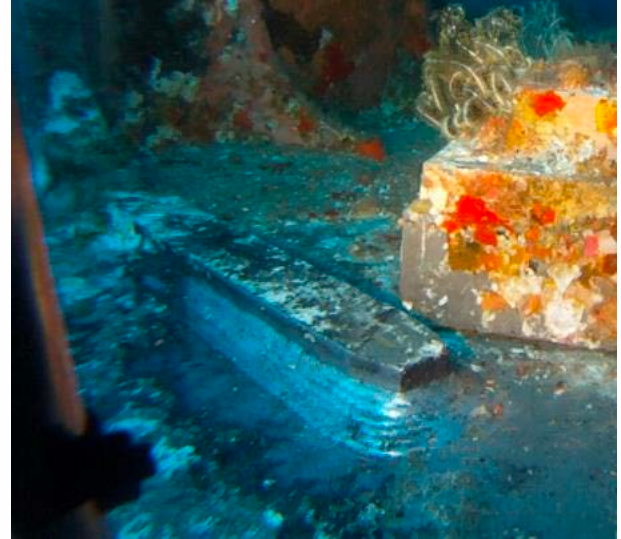
After Cleaning to expose Weld

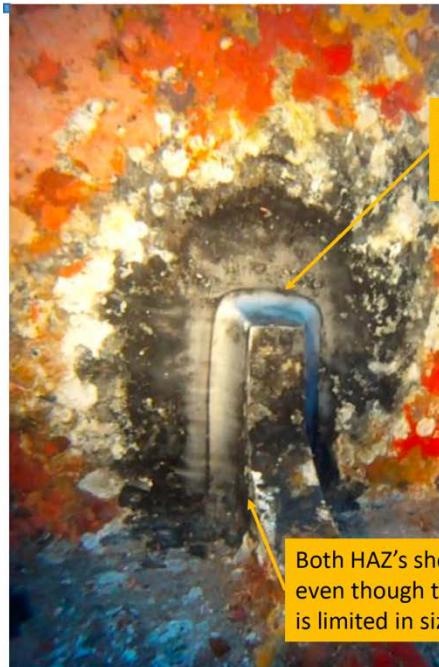
The profile weld toes should be cleaned of all MG and deposits.

Both HAZ's should be cleaned even though the gusset HAZ is limited in size, at the ends

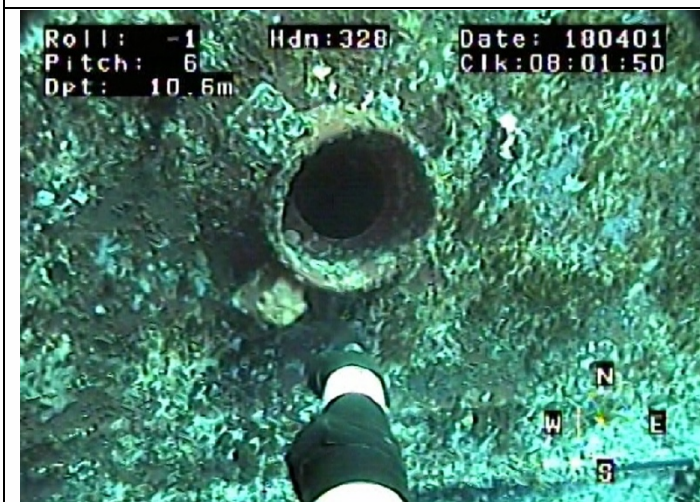
Overboard as found

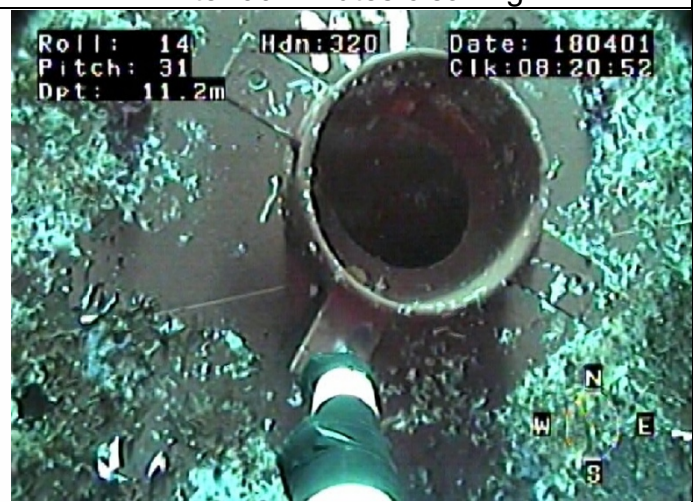
Overboard after 20 minutes cleaning

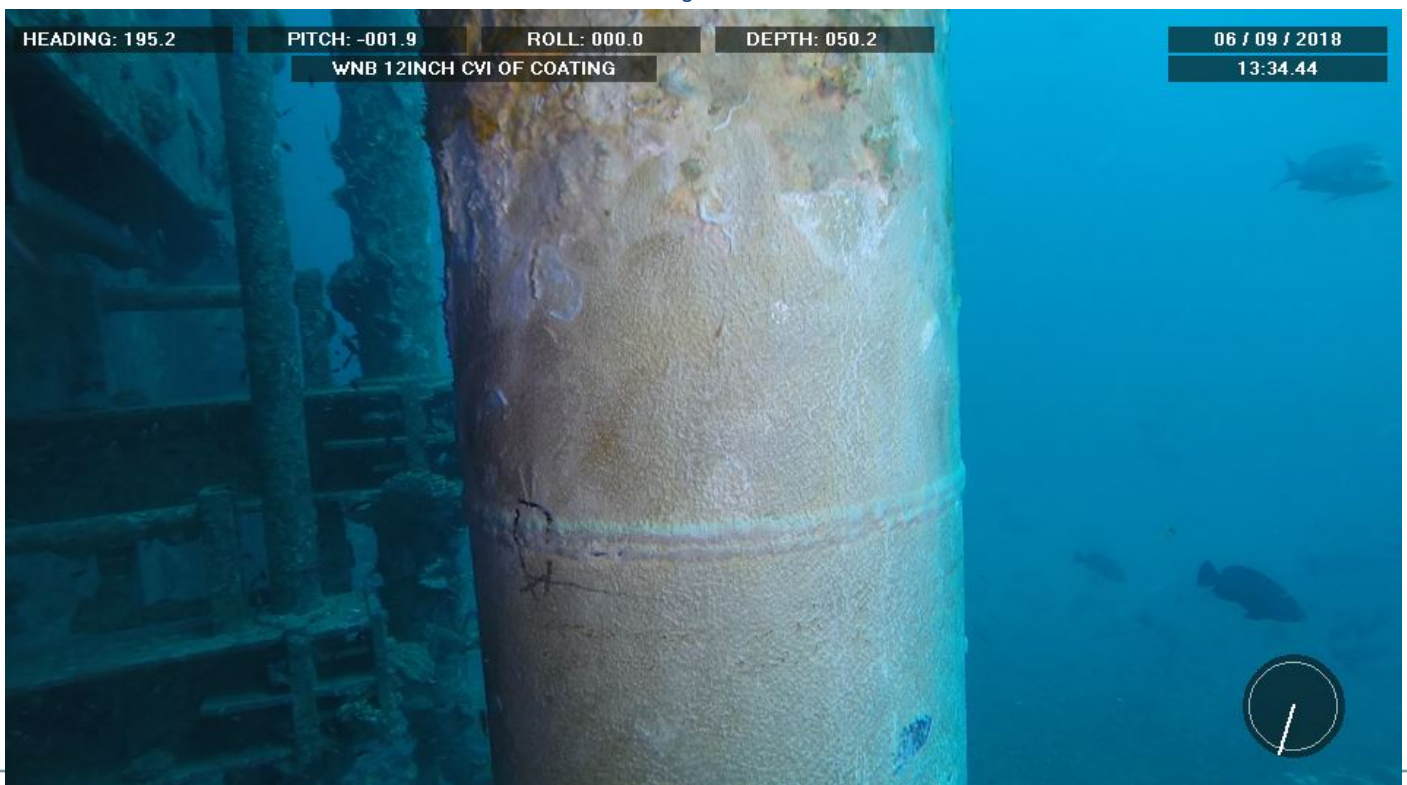
*Cleaned down the good coating prior to scanning and clamp installation*

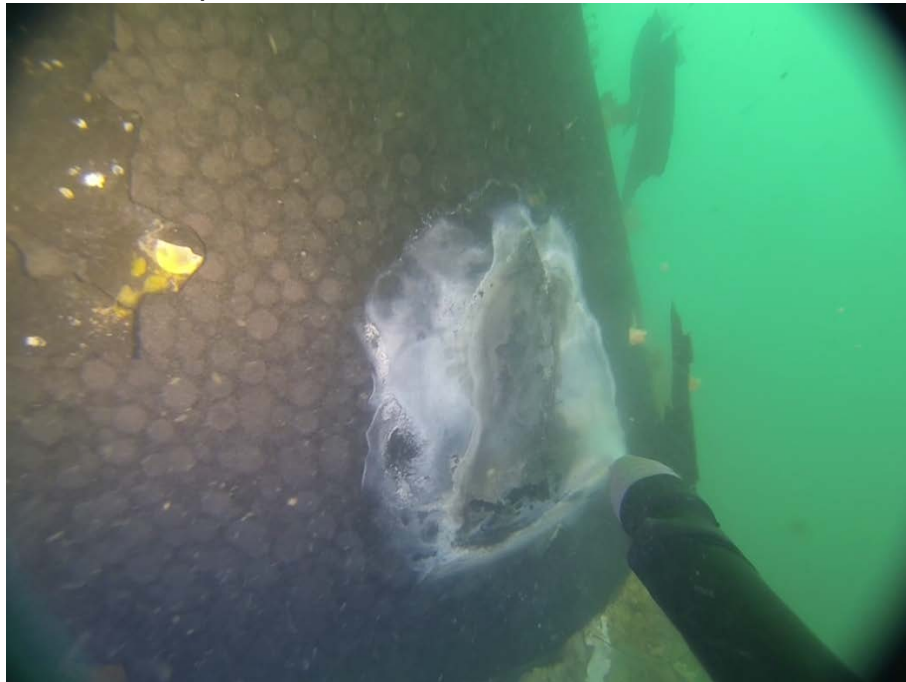
Jetty Piles (Darwin, Australia)

*Cleaning a pile – poor coating adhesion and areas of corrosion evident*

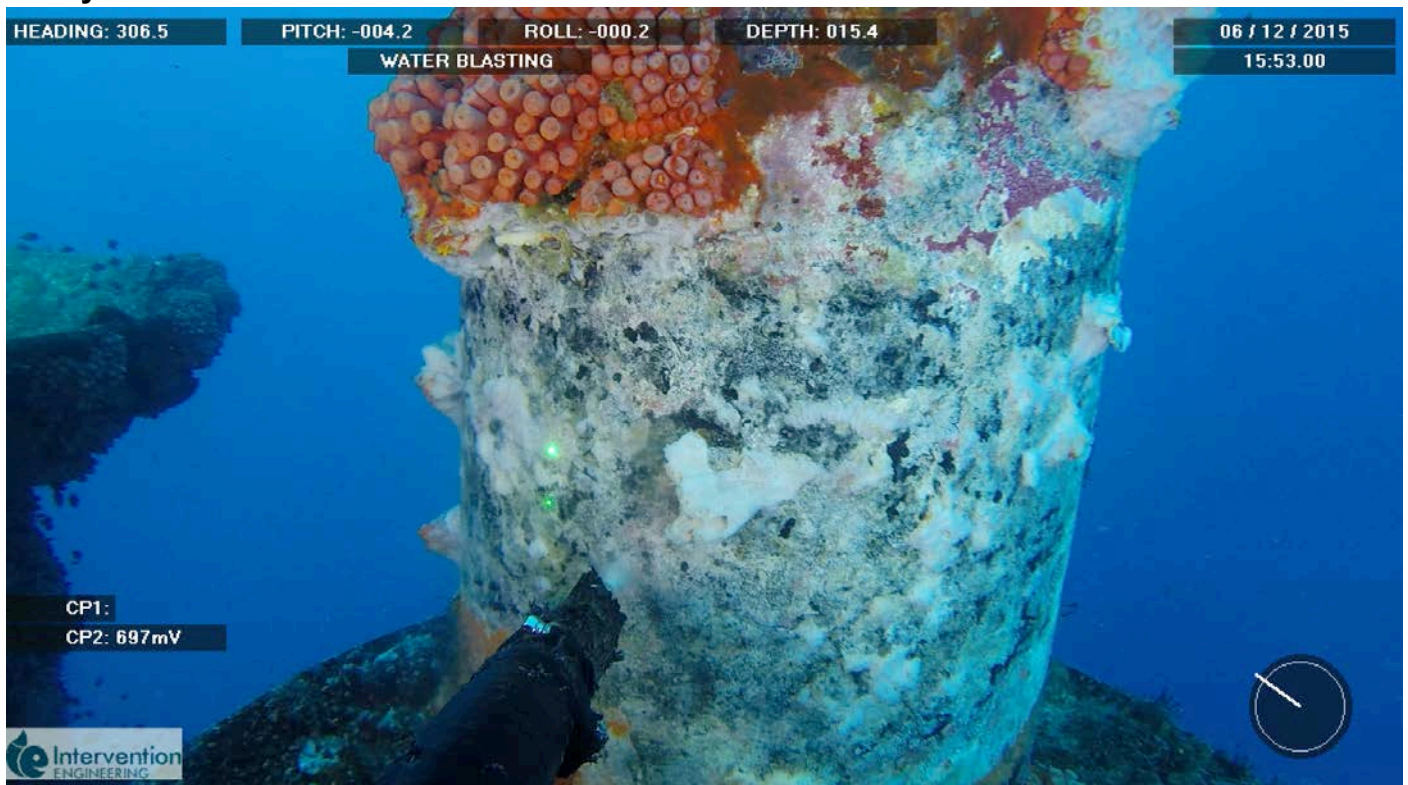
## Heavy Coral

*Hacking through the heavy coral – the nozzle is 60mm wide, so coral is well over 100mm*
